**State of Louisiana
Department of Natural Resources
Coastal Engineering Division**

**2005/2006 Annual Inspection
Report**

**BRADY CANAL HYDROLOGIC
RESTORATION**

State Project Number TE-28
Priority Project List 3

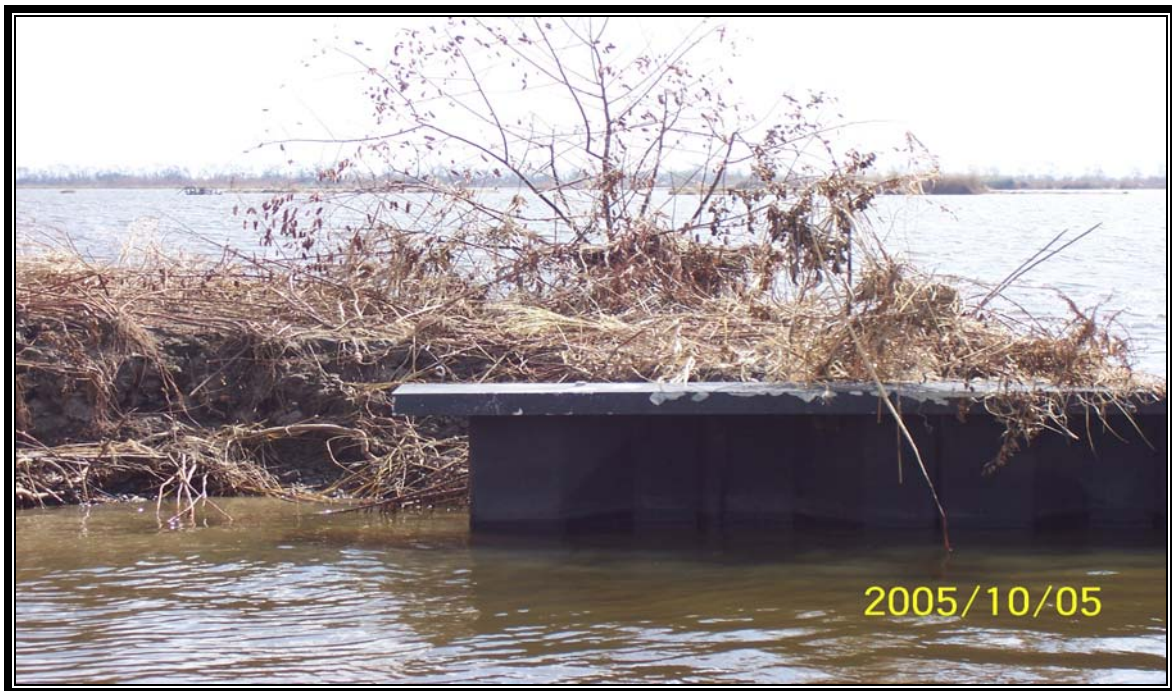
Structure No. 23 – Upon inspection of structure no. 23, we observed that the earthen embankment tie-in on the north side of the structure had eroded around the structure exposing the end of the steel bulkhead. There is a small portion of the earthen embankment remaining behind the structure on the marsh side preventing a breach from forming. This has been an area of concern during previous inspections and will require maintenance in the near future.

Structure #23 – significant erosion on the north side of the structure exposing the bulkhead.

Structure 23 - North earthen tie-in has eroded around steel bulkhead but has not breached. Watch closely on future site visits. No significant damage from storm. TBS installing stop logs.

The damage assessment of the Brady Canal Hydrologic Restoration Project (TE-28) revealed several breaches along the east bank of Carencro Bayou and Little Carencro Bayou and significant erosion adjacent to Structure No. 23 directly related to the storm surge produced by Hurricane Rita. It is recommended that the damaged mentioned above be restored using dredge material from the adjacent bayous and lake to raise the breached overflow banks and earthen tie-ins to their design elevation.

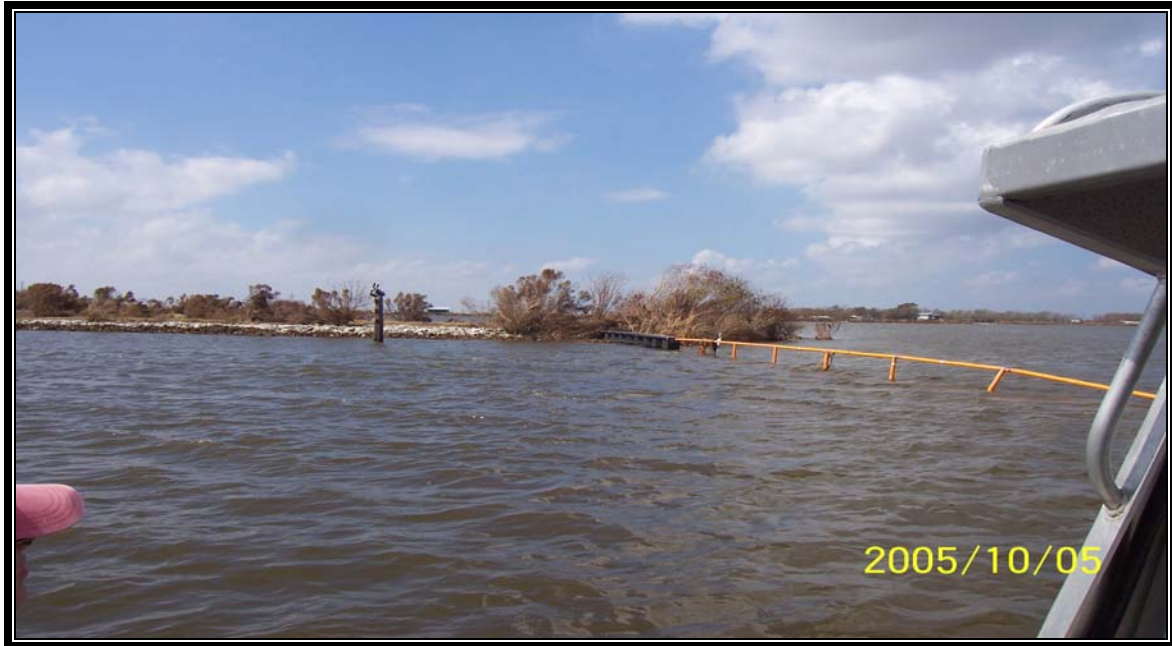
Structure No.6 – while inspecting the fixed crest weir with barge bay, we observed the guard rail at entrance to the barge bay on the west side was bent. This damage appears to be caused by oilfield barges accessing the barge bay and colliding with the bulkhead. No storm damage was noted.

Structure #6 – photo of bent guard rail on the west side of barge bay.

Structure No 6 - west of barge bay. Good condition west side of sheet pile wall damaged at entrance to barge bay. Staff gauge behind structure damaged.
No Reading

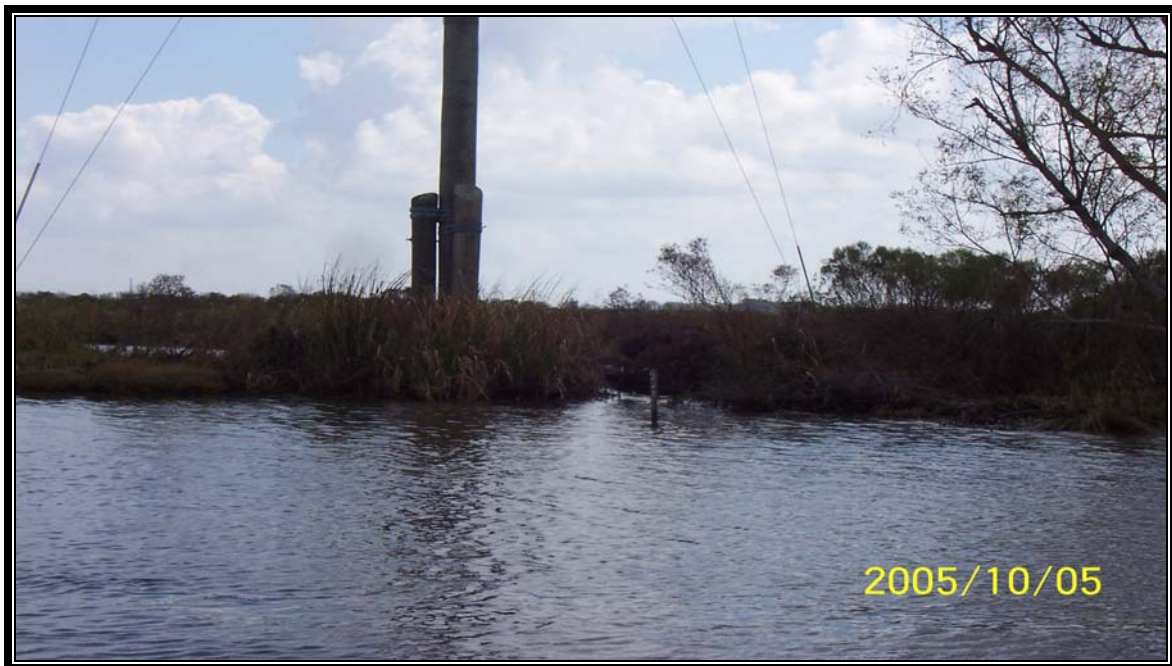
As noted in previous inspections, there is a small breach (approximately 5 feet wide) located on the east bank of Carencro Bayou across from an existing camp location between an electrical pole and guide wire. The breach doesn't appear to have worsened as a result of Hurricane Rita.

Photo of breach located along Carencro Bayou near electrical pole.

Small breach located along Commerce Bayou access from camp. Has not worsened from storm surge. Approximately 5' wide.

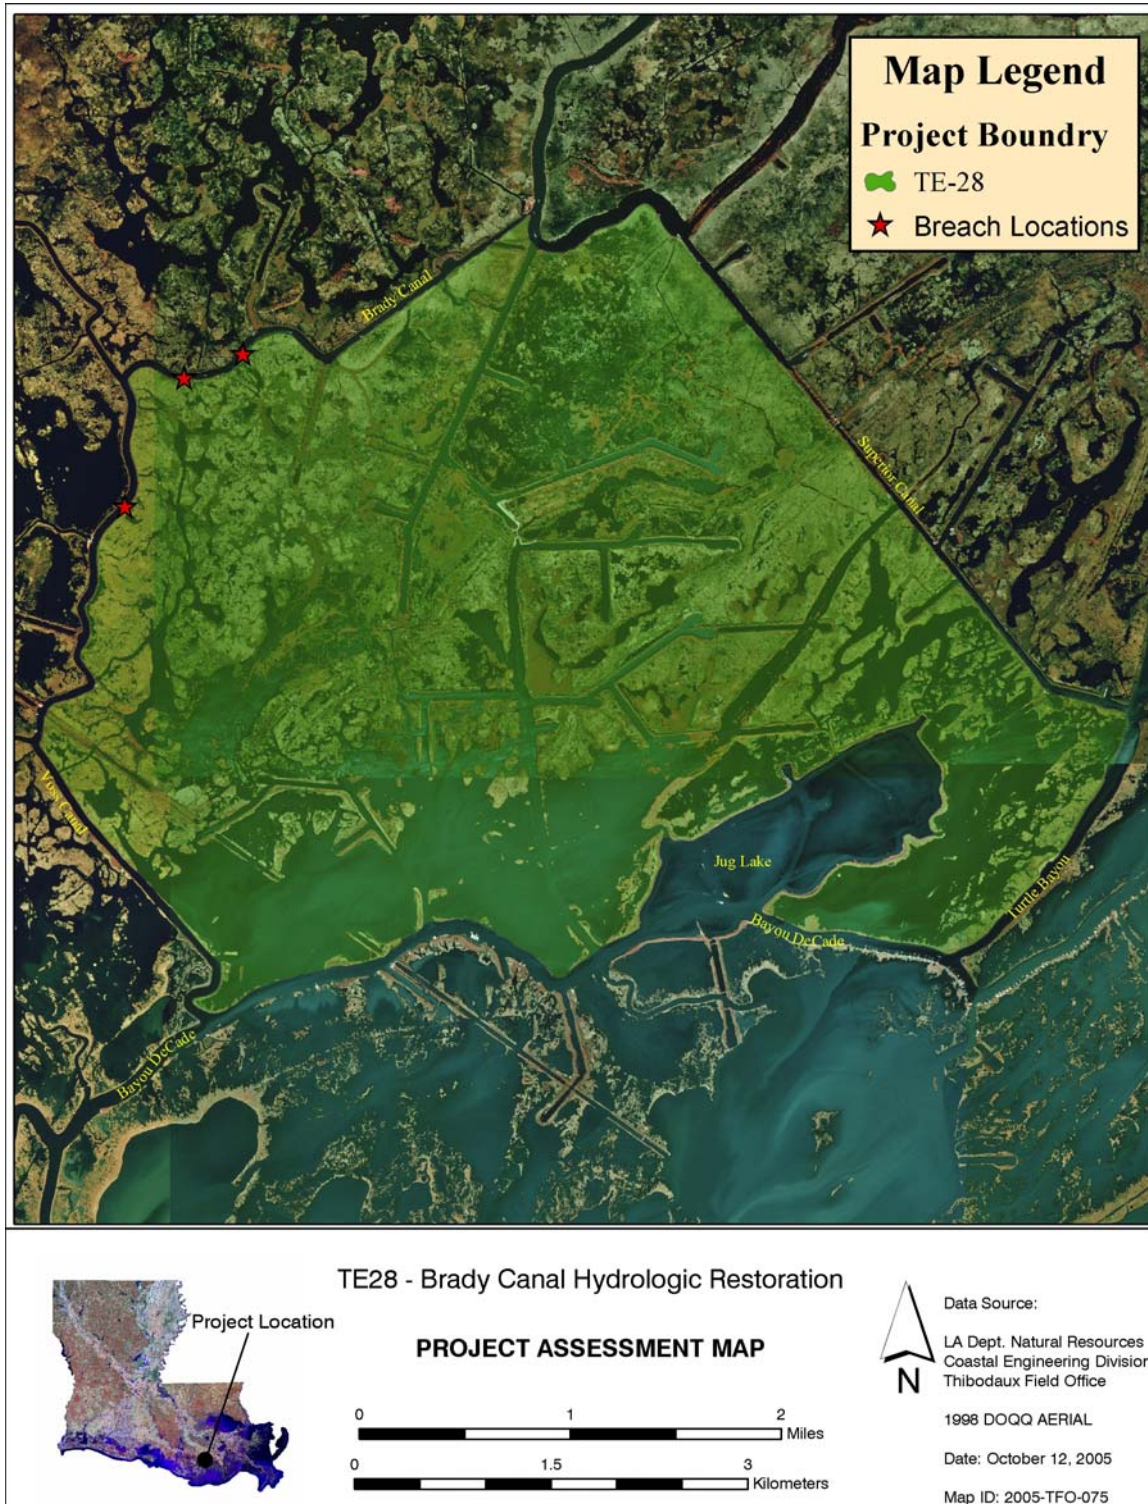
While inspecting the overflow banks along Carencro Bayou and Little Carencro Bayou, we observed three (3) breaches which were a direct result of Hurricane Rita. These earthen banks were in good condition and intact prior to the storm. Below is a map showing the approximate locations of these breaches along with photographs:

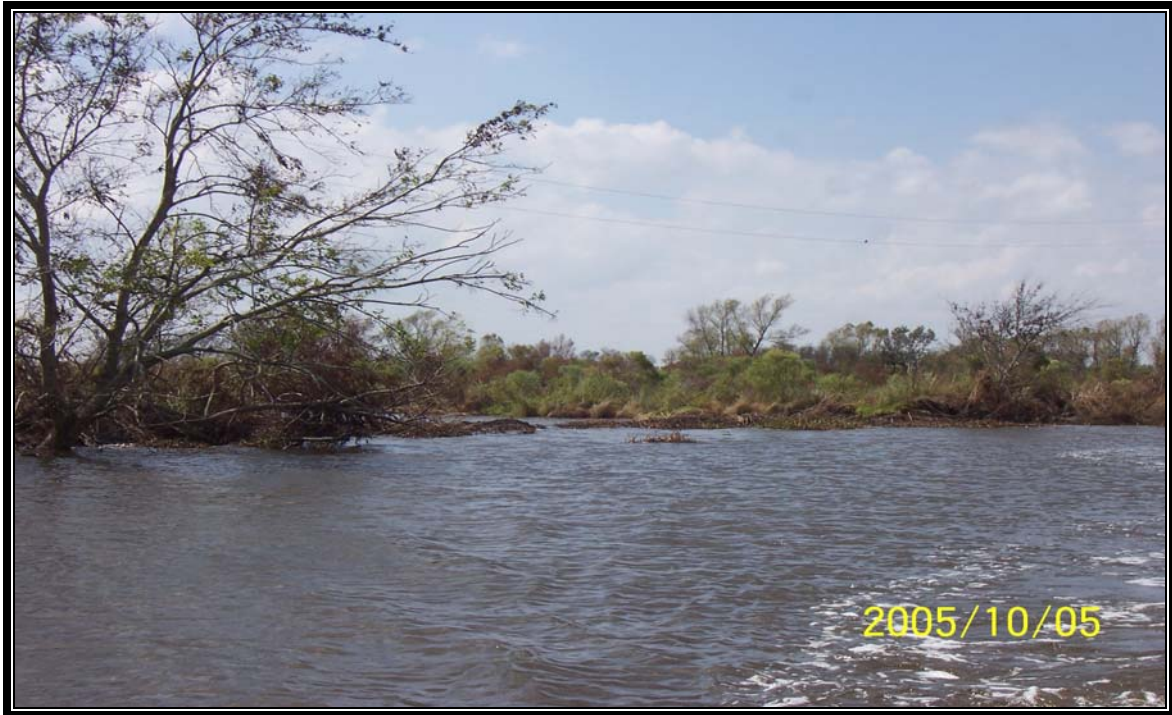
Photo of breach (approximately 20 ft. wide) located along east bank of Carencro Bayou.

Small breach^① along Carriero Bayou
(5' wide) - coordinates taken.
Breach due to storm.

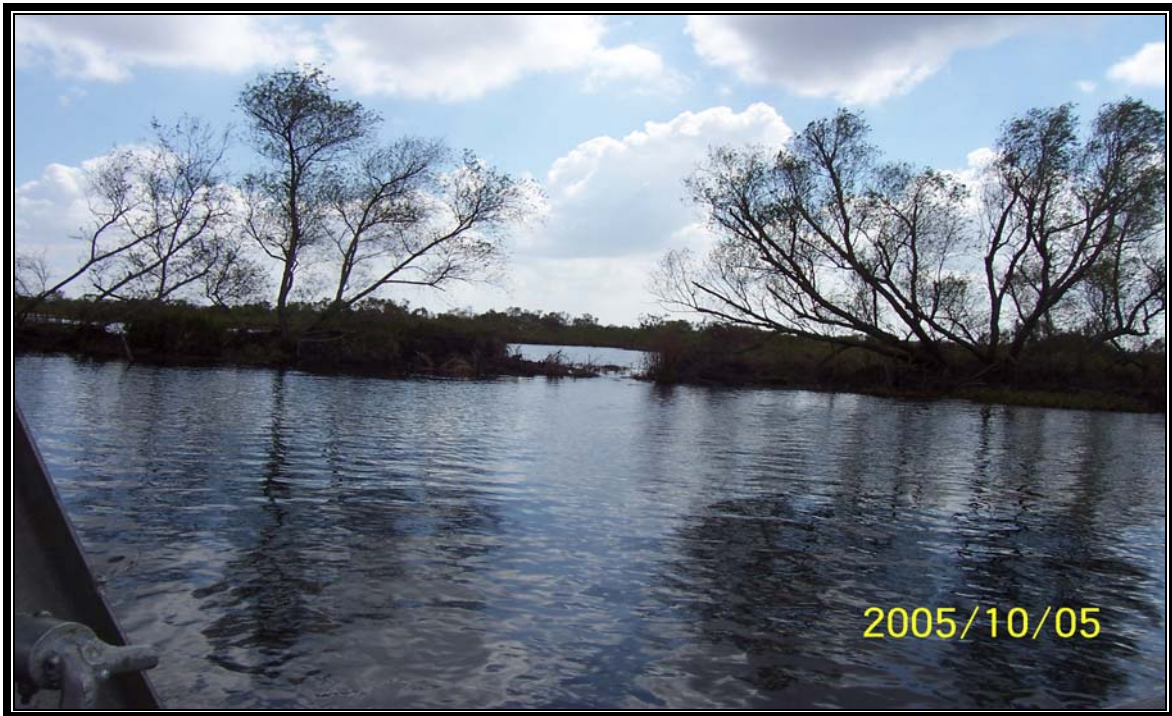
Photo of breach (approximately 25 ft wide) located along east bank of Little Carencro Bayou.

Little Carriero Breach^② 694,640 4' wide
Bayou 325,4630

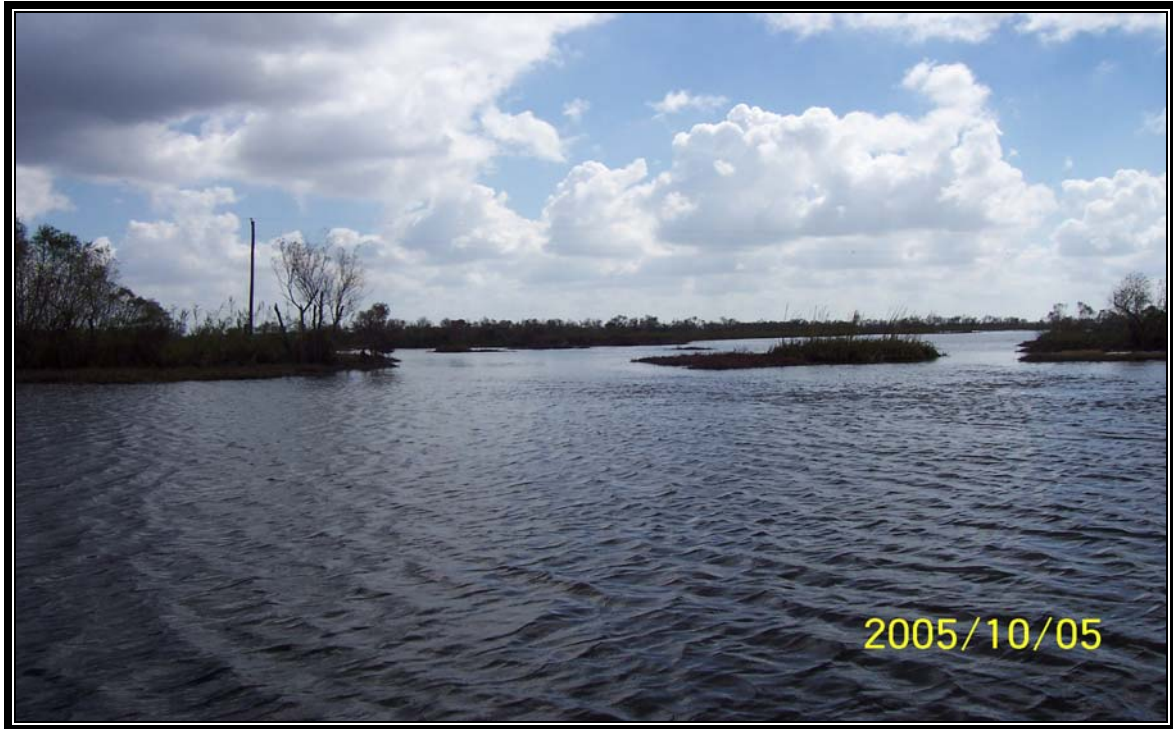
Photo of breach (approximately 80 ft wide) located along east bank of Little Carencro Bayou.

Breach^③ 695,090
Opposite ~~3,243~~ 3,254,863
80' wide
